FINAL REPORT ON COAL OUTBURST  
NO. 2 MINE  
CLINCHFIELD COAL CORPORATION  
DANTE, RUSSELL COUNTY, VIRGINIA  
May 20, 1948

Edward Thomas  
Mining Engineer

William R. Park  
Coal-Mine Inspector

UNITED STATES  
DEPARTMENT OF THE INTERIOR  
BUREAU OF MINES

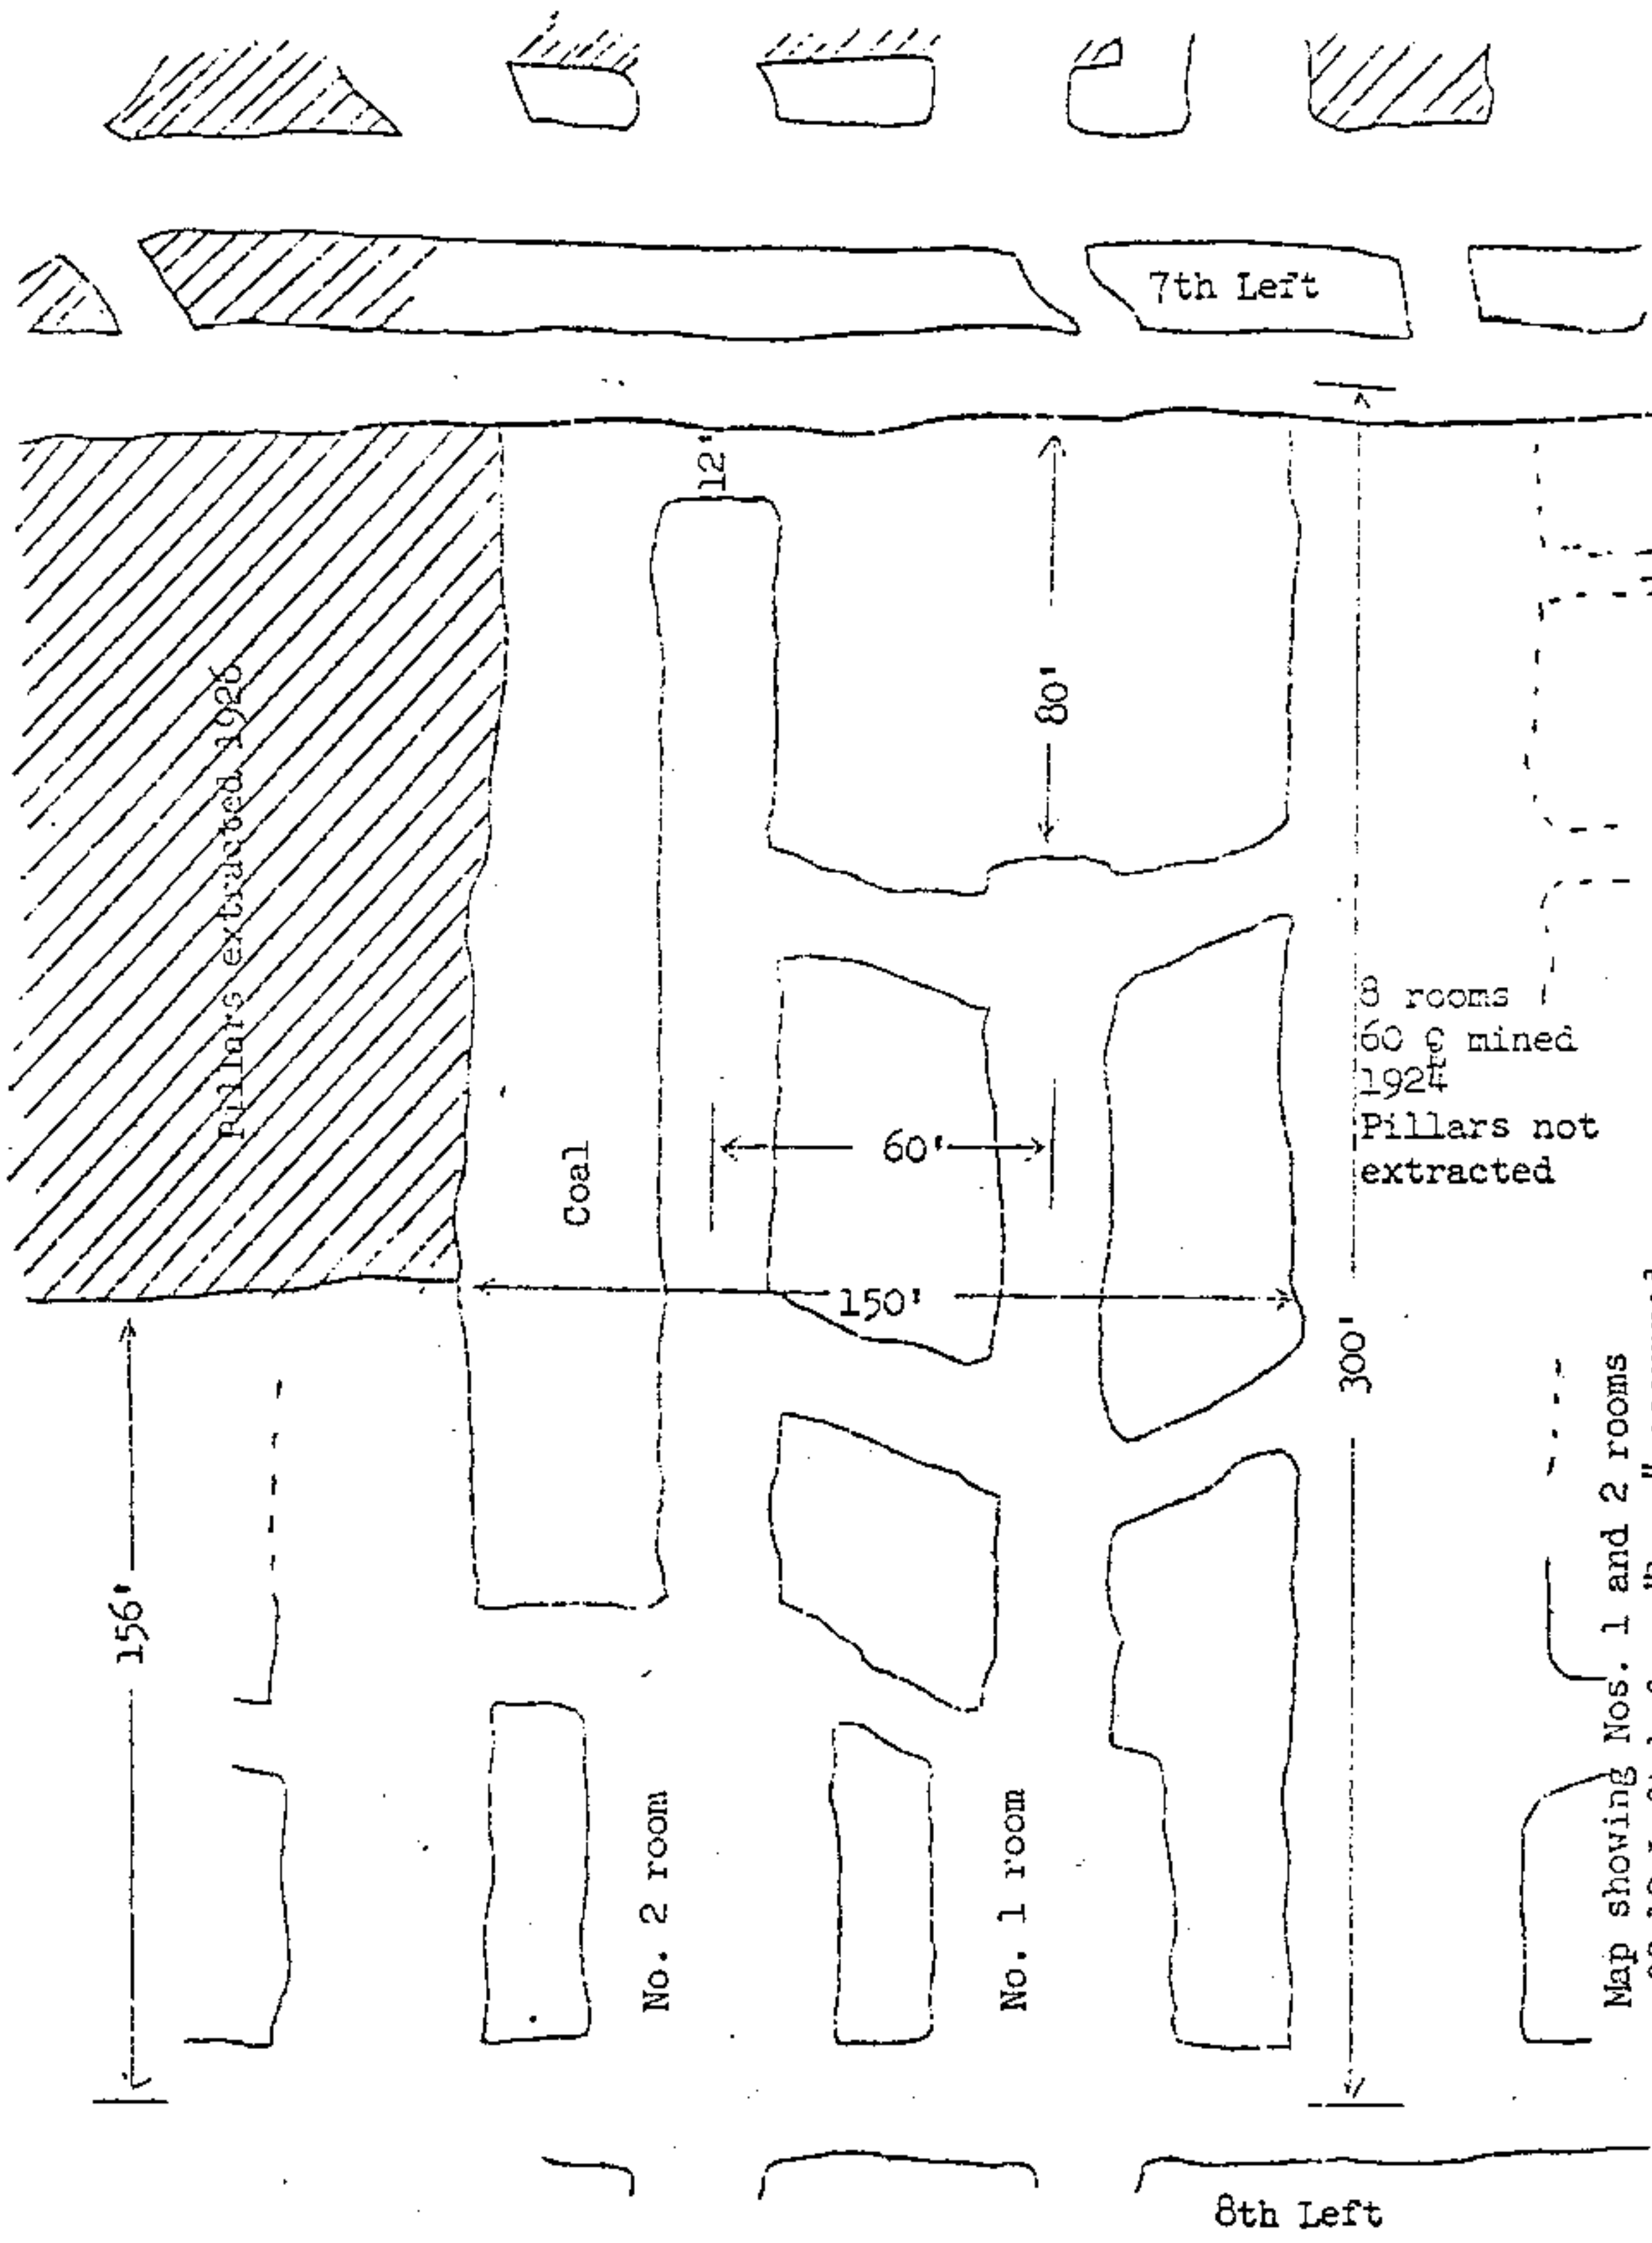
Appendix III

8 rooms  
60' x mined  
1924  
Pillars not  
extracted

Pillars extracted 1926

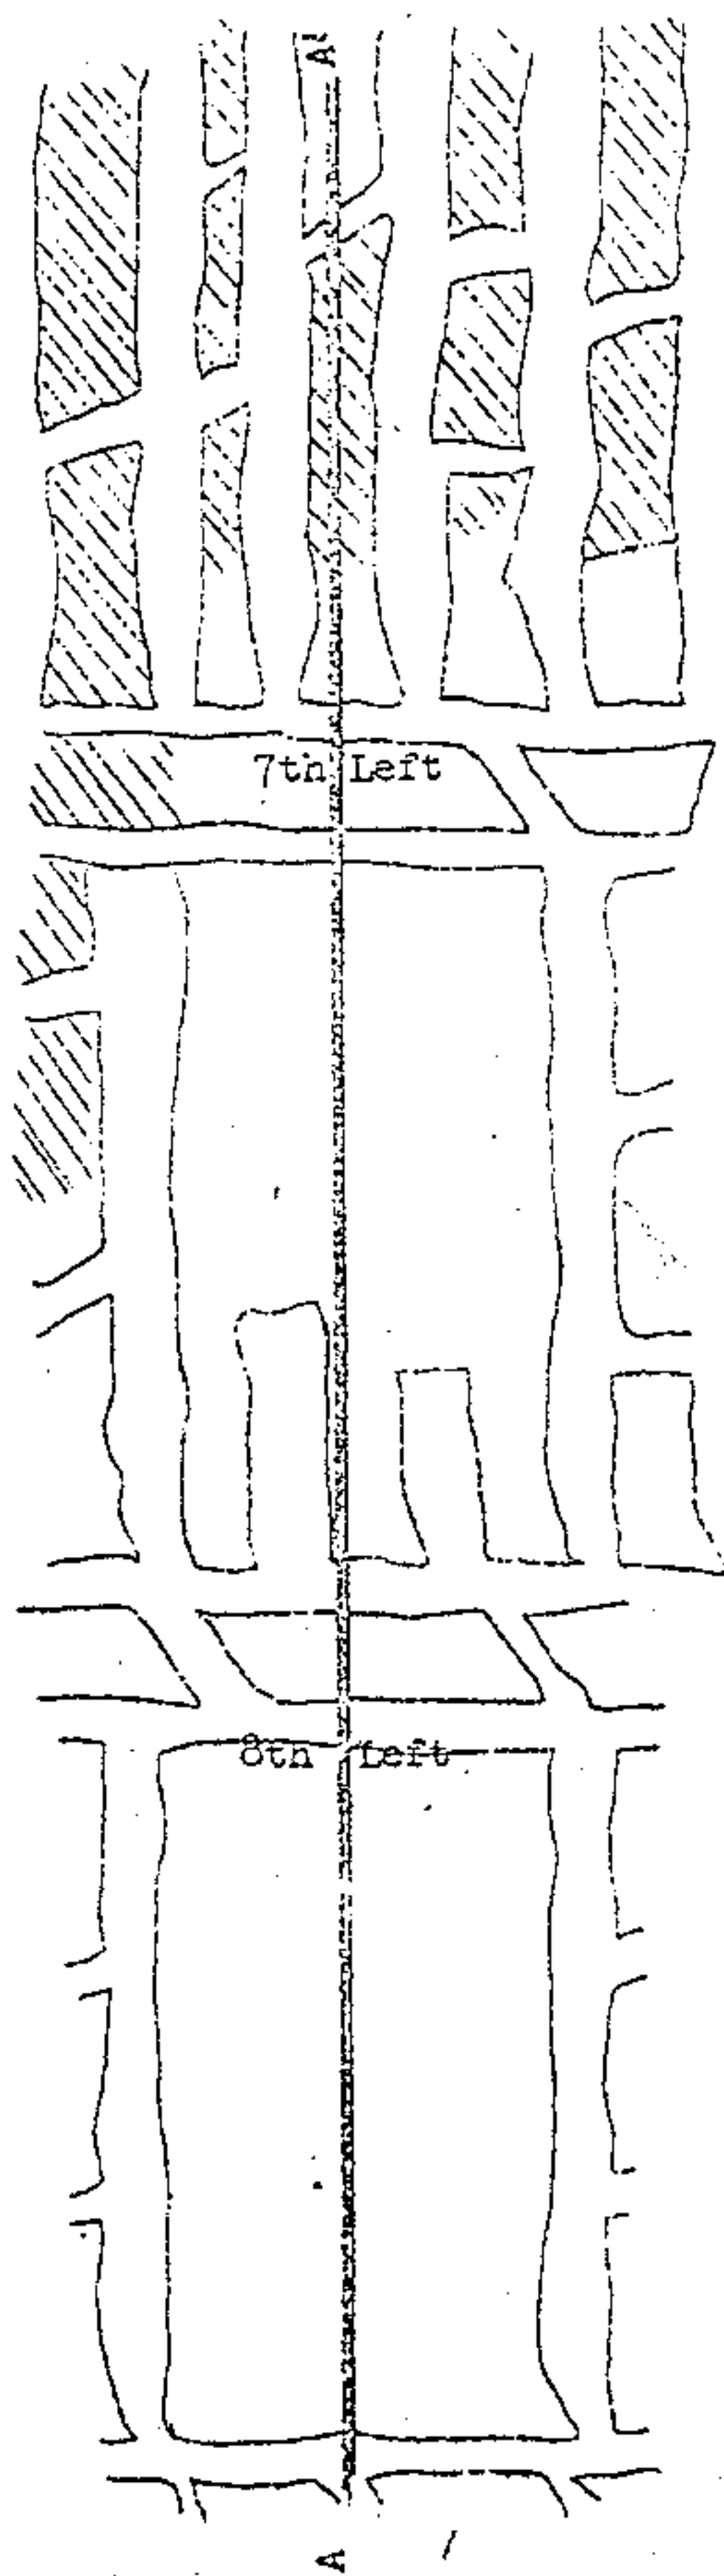
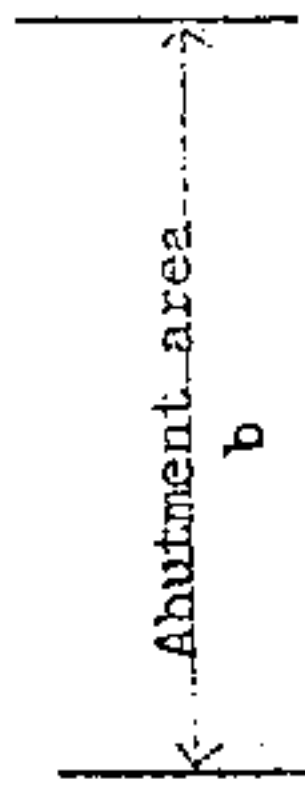
Section on line A-A' showing condition before  
barrier pillar was mined

Examination of the face area to the left of the barrier pillar (19 left off 12 left) in which the outburst occurred, revealed evidence that substantial caves had not been made on the main pillar line before it was abandoned in 1926. Inasmuch as this was the only substantial pillar in the area and, together with pillar remnants on 7 left, projected well out into the goaf, it is reasonable to suppose that there was an impingement of stresses on this, the only solid block of coal in the area which was able to bear a great amount of stress without undue crushing. Thus a condition illustrated by figure 3 was present. That is, after the pillar line was abandoned, the weight of the cantilevered strata over the goaf crushed the 7 left pillar remnants and the near end of the large pillar (a) until the restraining action of the failed coal prevented lateral expansion. The convergence of the floor and roof ceased when the core of the pillar resisted further deformation through compression. Thus an equilibrium of stresses was reached at some point within the abutment area and

(b) an enormous amount of elastic energy was stored. When the pillar was being split by driving two openings toward the goaf, one or more coal outbursts were inevitable as soon as the faces reached the critical point in the abutment area where the resistance of the solid coal was insufficient to withstand the pressure being exerted outward from the core of the pillar. As shown in figure 4, the pillar virtually exploded when the restraining material was removed. The forces were outward rather than toward the goaf because the fulcrum of the lever, causing the pressure, was in the goaf and the action was similar so that of a pumpkin seed when squeezed between the thumb and forefinger.

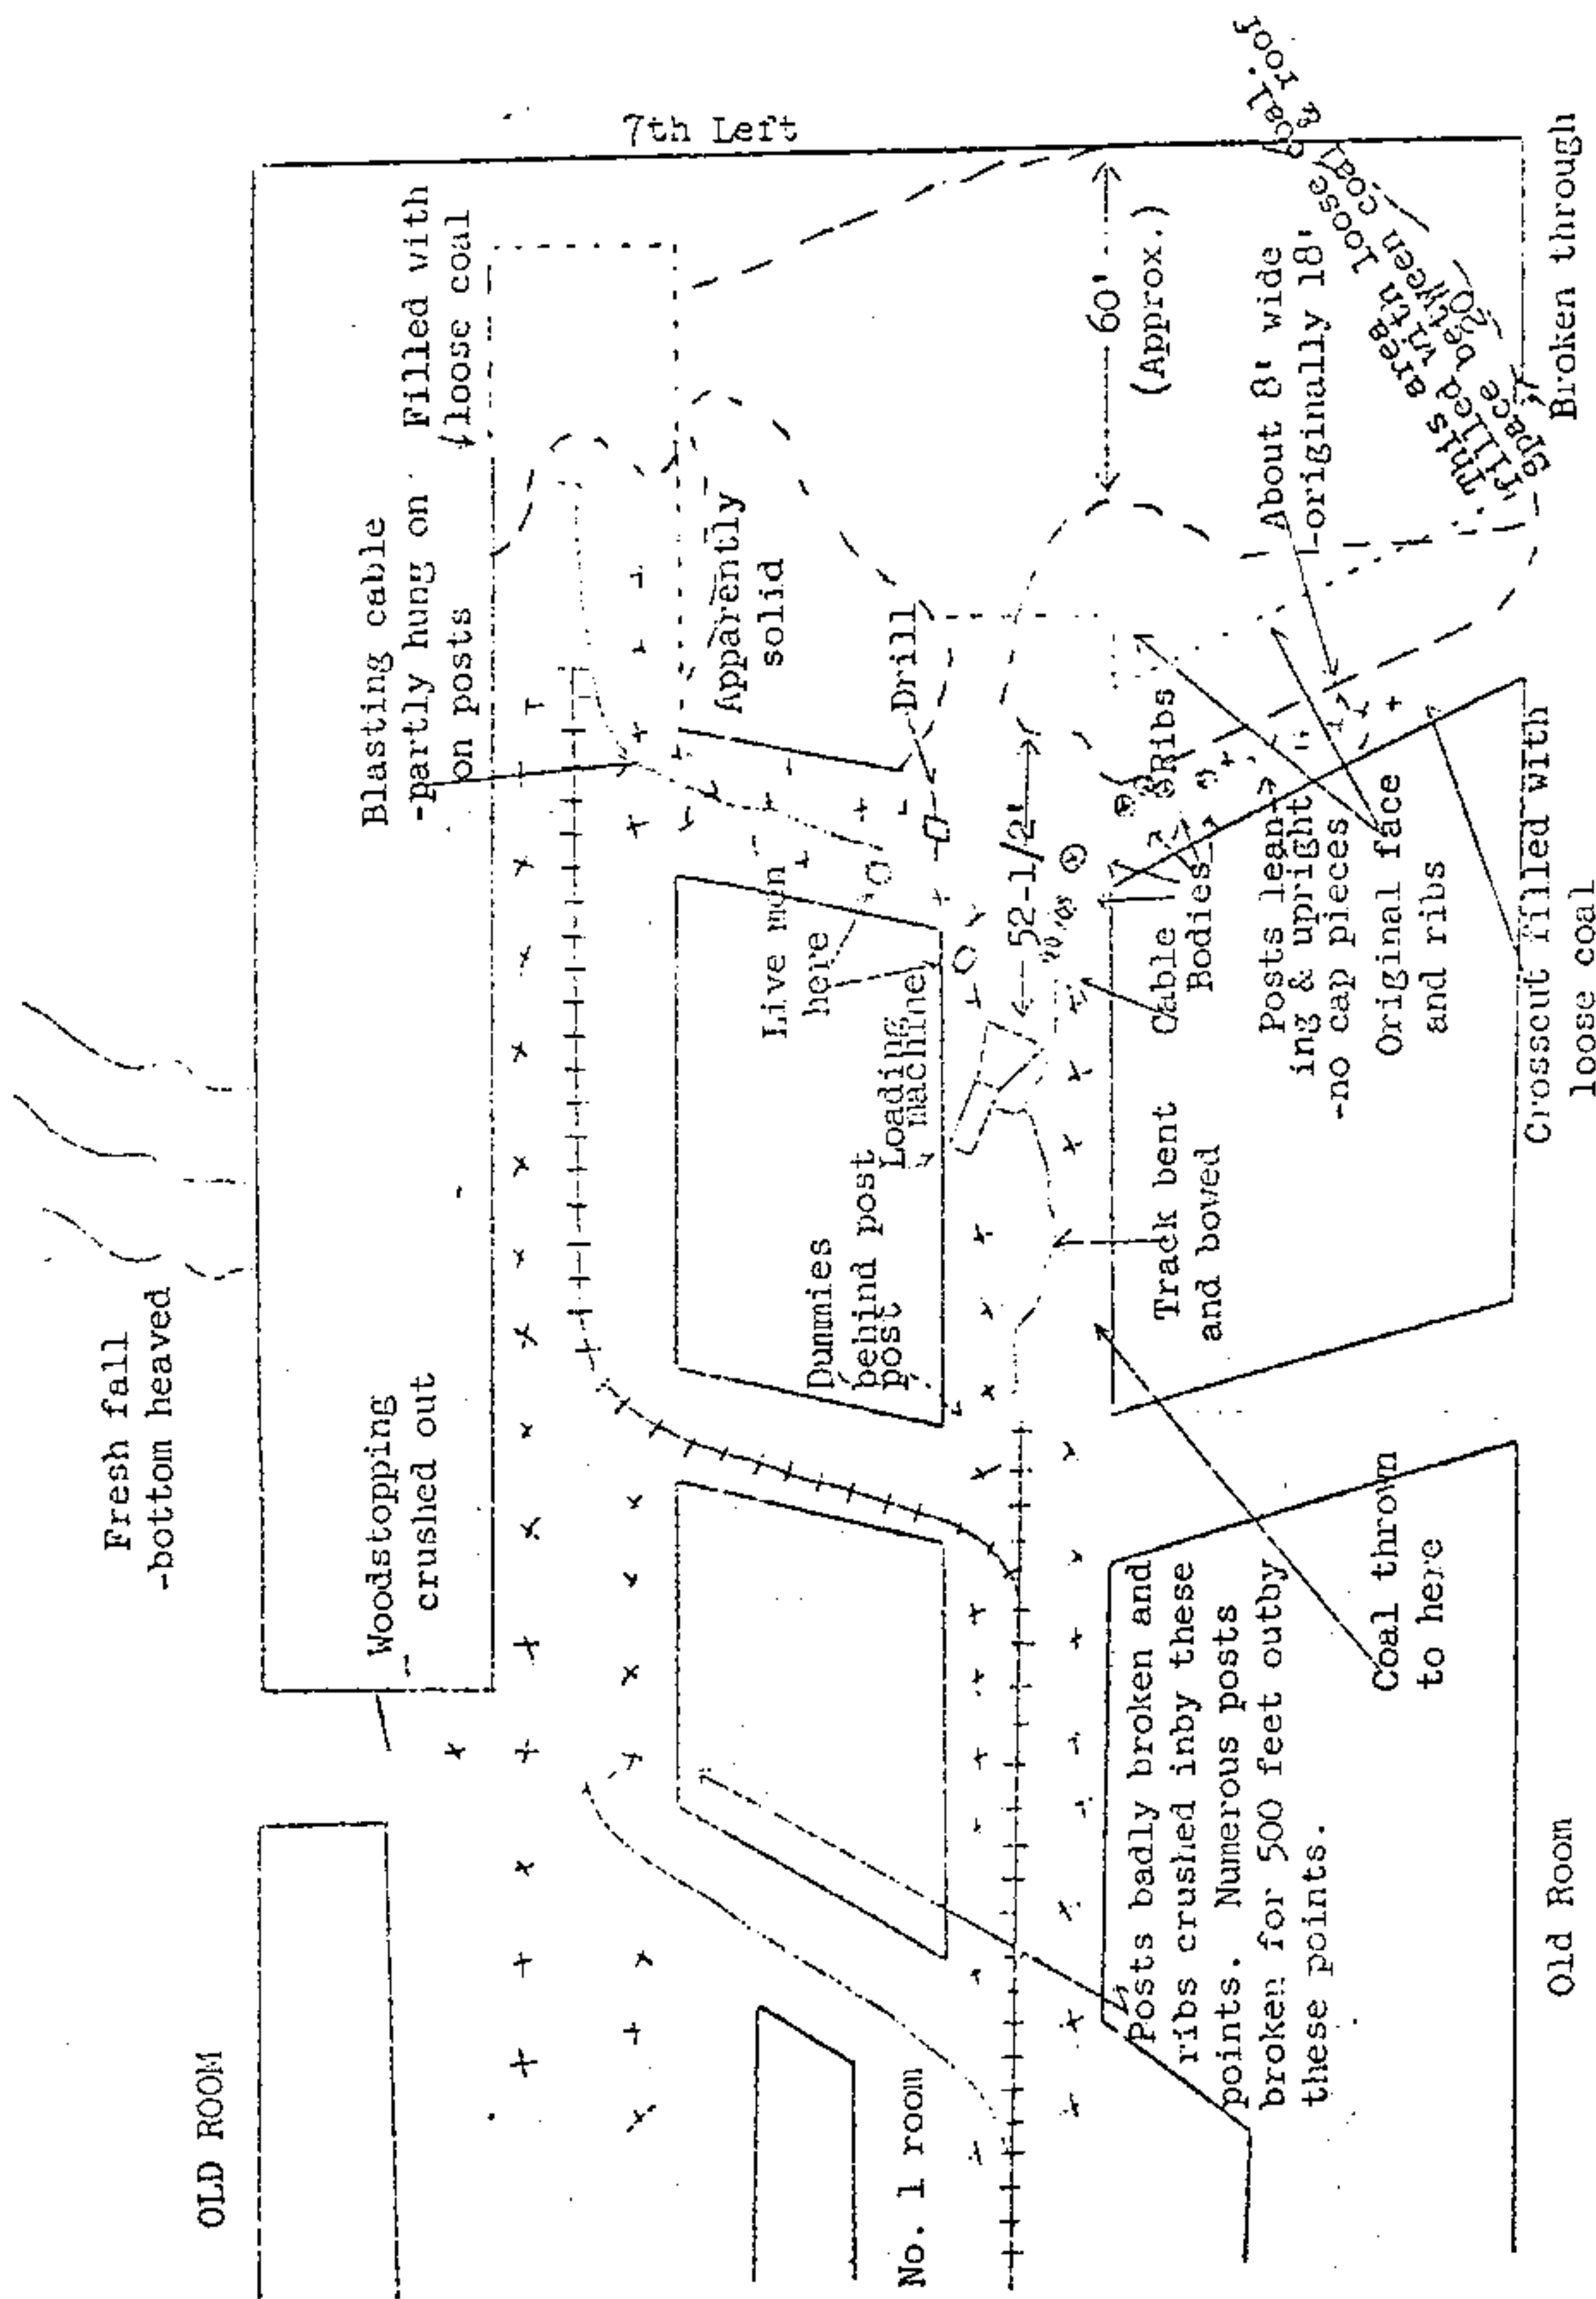
Appendix V

The Nos. 1 and 2 rooms off 19 left off 12 left were being driven through a partly mined block of coal, 300 feet in length and 150 feet in width. The Nos. 1 and 2 rooms (actually Nos. 29 and 30 rooms off 8 left entry) were turned on 60-foot centers, were 24 feet wide near the faces and were driven 208 and 289 feet in depth, respectively, when the outburst occurred. The face of No. 1 room was 6 to 10 feet inby crosscuts to the right and left off No. 1 room. The No. 2 room had been driven about 80 feet inby the face of No. 1 room. Several hundred tons of coal was dislodged; coal was thrown 75 feet outby the face along the No. 1 room tracks; the right crosscut (18 feet wide and 40 feet in depth) was filled with thrown coal; the block of coal inby the original face to probably the 7 left air course (80 to 90 feet) was dislodged; the coal to the right of No. 1 room (40 feet wide) was dislodged and shattered; and the block of coal between Nos. 1 and 2 rooms was dislodged and shattered, especially near the face of No. 2 room. Details are given in figure 4. The loading machine was shoved about 60 feet outby the face, and the end of the loading boom was forced against an offset in the left rib of No. 1 room. The track near the loading machine was twisted and bent; also numerous timbers in the crosscut to the right of No. 1 room and in No. 1 room were dislodged.

This coal dislodged &  
moved in one piece
